# Clearcoat Yellowing

# Dirt Inclusions

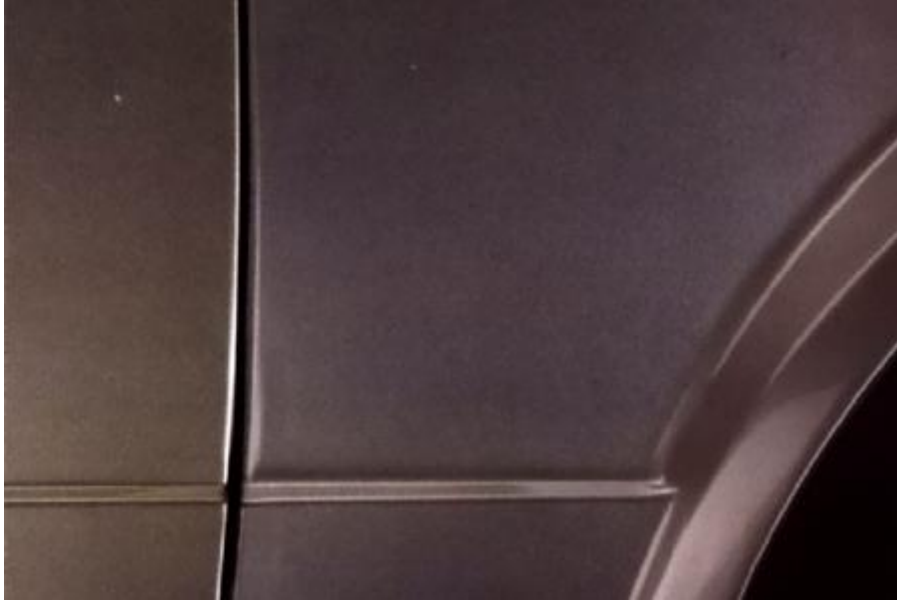
Discoloration causing the appearance of a color mismatch to the adjacent panel after the clearcoat is applied.

- Wrong or contaminated hardener/activator.
- Incorrect clearcoat film thickness

Allow the finish to properly dry, then sand and refinish.

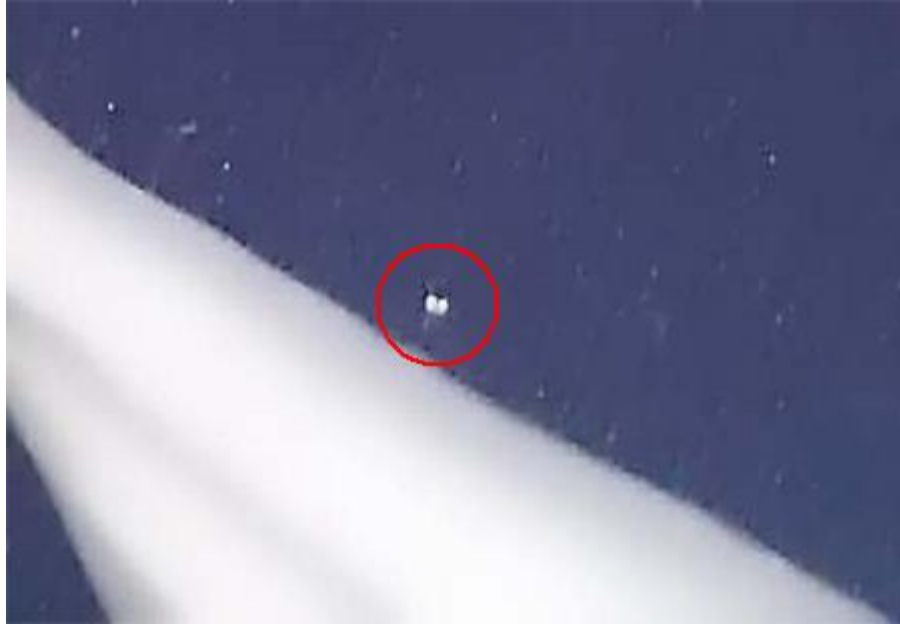
A surface with this defect will show particles of different sizes deposited in the primer or color.

- Various types of contamination typically introduced during the application or drying process.
- Static charge on surface of vehicle. This condition helps the attraction of dust.
- Dust and dirt from dry sanding, cloths, etc.
- Use of poor quality masking paper.
- Tack rag was not used before spraying, or not immediately before.
- Inadequate filtration of air.
- Dry spray dust settling on wet paint.
- Paint kept in dirty containers/tins.
- Paint was not strained.
- Operators clothing bearing dirt, fibres and dust.
- Paint has been kept longer than recommended.
- Inadequate filtration of compressed air.
- Activator or thinner used were incorrect.
- The car was not thoroughly blown out.
- Tintings/pigments were not sufficiently stirred.
- Spray dust accumulated on spray booth surfaces/walls.
- Use, re-thinned, of 2K materials after the recommended potlife.

- Allow the finish to harden completely, fine sand and polish.
- If the defect is severe, sand and respray.

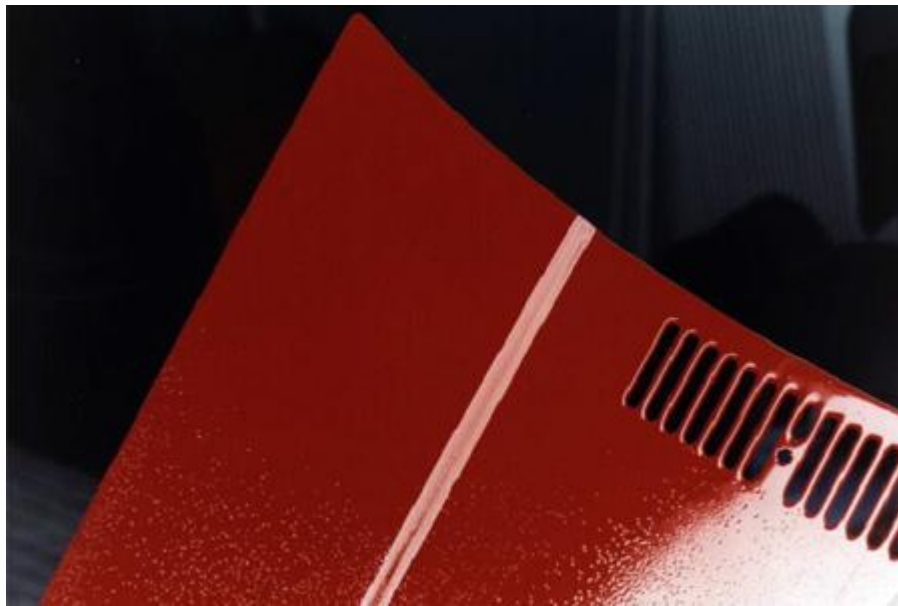
## Fish Eyes

Small, crater-like opening in the finish after it has been applied.

- Improper or insufficient surface cleaning or preparation. Many waxes and polishes contain silicone, the most common cause of fish eyes. Silicones adhere firmly to the paint film and require extra effort for their removal. Even small quantities in sanding dust, rags can cause this type of failure.
- Effects of the old finish or previous repair. The old finish or previous repair may contain excessive amounts of silicone from additives used during their application. Usually solvent wiping will not remove embedded silicone.
- Contamination of air supply, by water or oil.
- Oil, wax, grease or silicone contamination.
- Use of silicone-containing polishes or aerosol sprays (e.g.: interior cleaners or dressings) in proximity to the spray area.

- Apply light coats of basecoat until defect is covered.
- If required or recommended, use fish-eye eliminator.
- In severe cases, sand the affected areas, clean thoroughly, isolate and refinish.

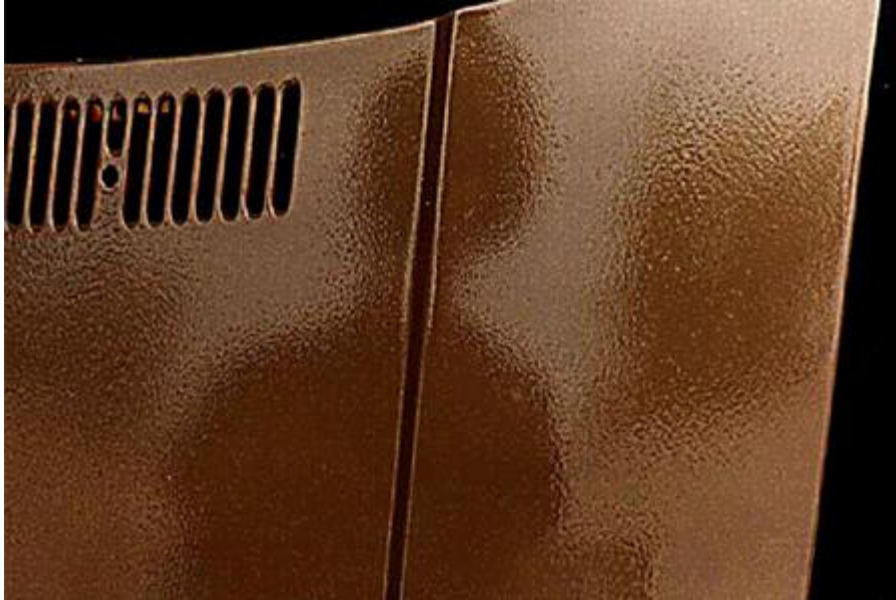
## Orange Peel

Uneven surface formation - much like that of the skin of an orange - which results from poor coalescence of atomized paint droplets. Paint droplets dry before they can flow out and level smoothly together.

- Improper gun adjustment and techniques. Too little air pressure, wide fan patterns or spraying at excessive gun distances causes droplets to become too dry during their travel time to the work surface and they remain as formed by gun nozzle.

- Extreme shop temperature. When air temperature is too high, droplets lose more solvent and dry out before they can flow and level properly.
- Improper dry. Gun fanning before paint droplets have a chance to flow together will cause orange peel.

- Improper flash or recoat time between coats. If first coats of enamel are allowed to become too dry, solvent in the paint droplets of following coats will be absorbed into the first coat before proper flow is achieved.

- Wrong thinner or reducer. Under-diluted paint or paint thinned with fast evaporating thinners or reducers causes the atomized droplets to become too dry before reaching the surface. Too high viscosity.

- Low shop temperature.
- Too little thinner or reducer.
- Materials not uniformly mixed. Many finishes are formulated with components that aid coalescence. If these are not properly mixed, orange peel will result.

- Substrate not sanded thoroughly

- For mild cases, sand and polish using recommended materials and techniques.
- In extreme cases, sand down to smooth surface and refinish, using a slower evaporating thinner or reducer at the correct air pressure.

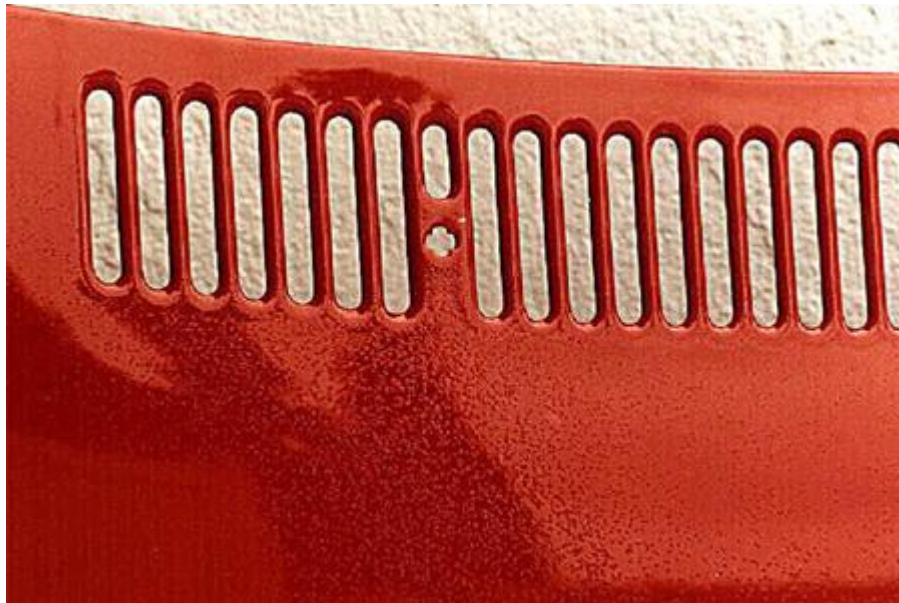
## solvent Pop

Blisters on the paint surface caused by trapped solvents in the topcoats or primer-surfacer, a situation which is further aggravated by force drying or uneven heating.

- Solvent or air trapped in film escapes during drying leaving pop marks.
- Incorrect spray viscosity, spray pressure, flash off time, or improper drying.
- Incorrect choice of hardeners and/or thinners. Use of fast-dry thinner or reducer, especially when the material is sprayed too dry or at excessive pressure.
- Excessive film thickness. Insufficient drying time between coats and too heavy application of the undercoats may trap solvents causing popping of the color coat as they later escape.
- Incorrect drying of primer / fillers.
- Improper surface cleaning or preparation.
- Infrared facilities too close.
- Baking was started too soon after application.
- Baking temperature too high.

- If damage is extensive and severe, paint must be removed down to undercoat or metal, depending on depth of blisters; then refinish.
- In less severe cases, sand until smooth, resurface and refinish.

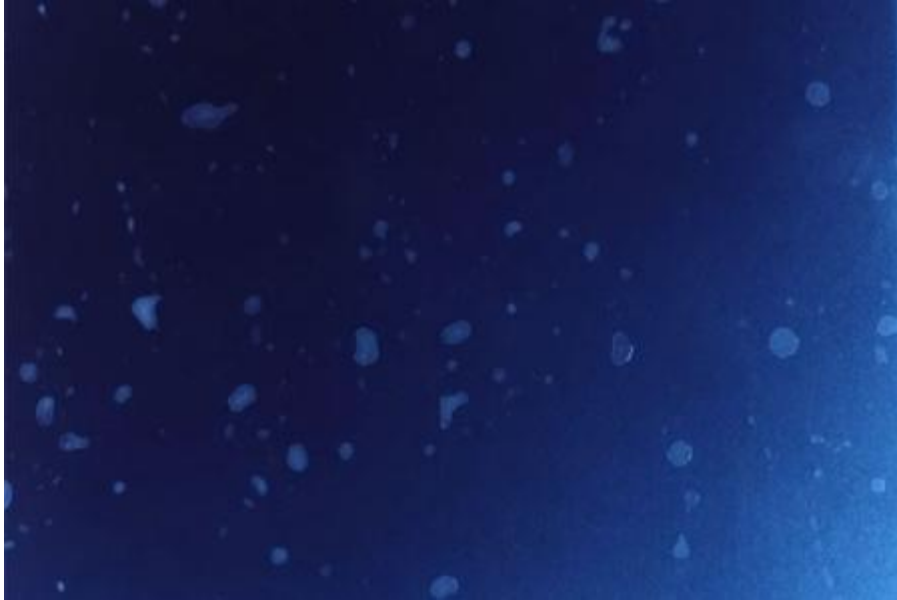
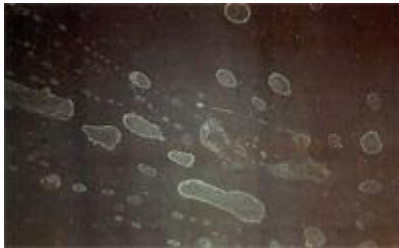
## **Water Spotting**

General dulling of gloss in spots or masses of spots.

- Washing finish in bright sunlight.
- Droplets of water evaporating on finish which is not sufficiently cured due to:
  - Excessive film thickness, drying time too short
  - Failure of cross linking due to moisture contamination
  - Unsuitable thinner

- Remove marks by compounding or polishing.
- In severe cases, sand affected areas, isolate and refinish.

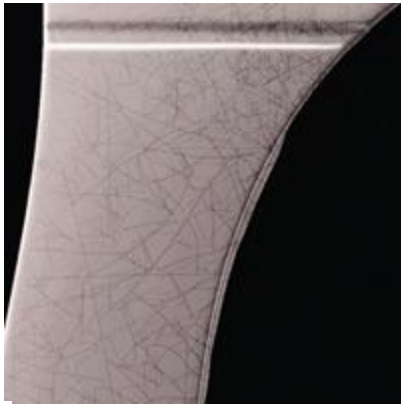
## **Cracking**

A series of deep cracks resembling mud cracks in a dry pond. Often in the form of three-legged stars and in no definite pattern, they are usually in the color coat and sometimes the undercoat as well.

- Excessive film thickness. Excessively thick topcoats magnify normal stresses and strains which can result in cracking even under normal conditions.
- Materials not uniformly mixed.
- Insufficient flash times between coats.
- Incorrect use of additives.
- Substrate is too hot or cold.
- Use of coats incompatible with each other.
- Omitting the activator when mixing a 2K product.

The affected areas must be sanded to a smooth finish, or in extreme cases removed down to the bare metal, and a full refinish system reapplied.
